Bavarian Air Crash

Graham Ward

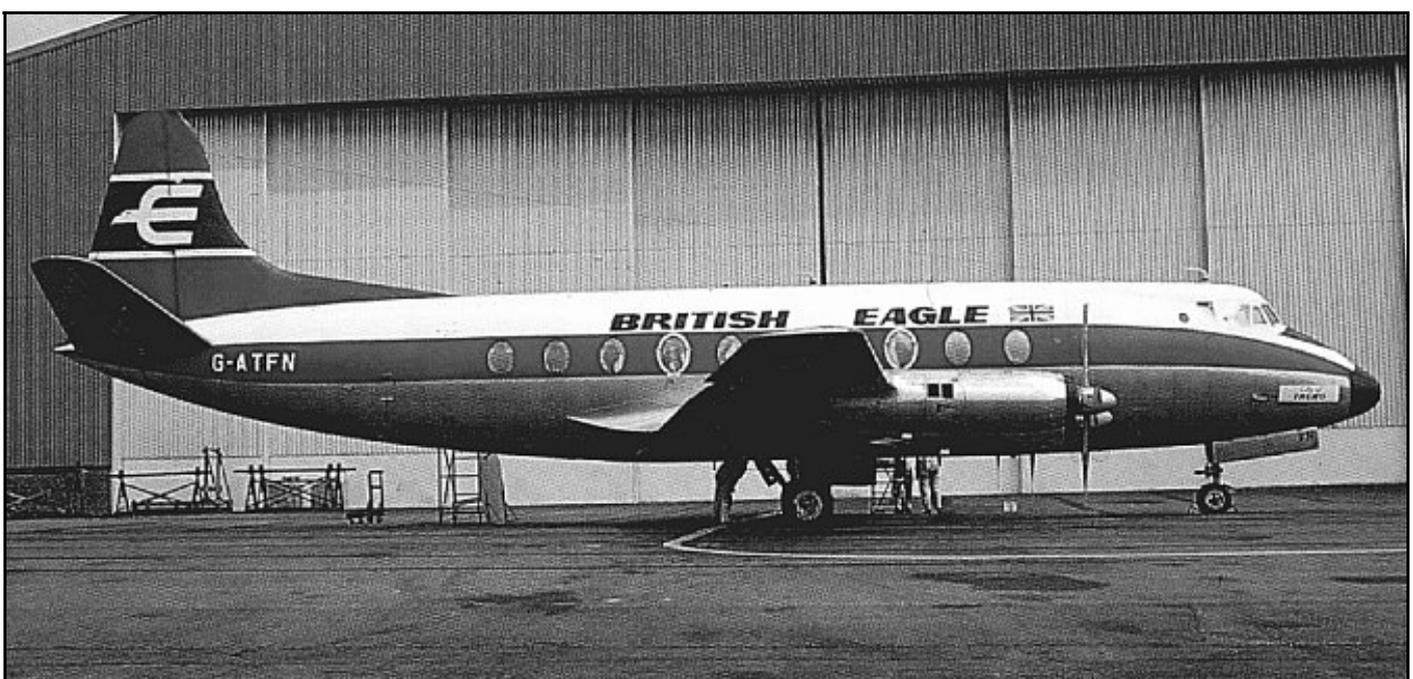
The ill-fated British Eagle Viscount G-ATFN, *City of Truro*
